SUBJECT: CLEAN AIR ACT INSPECTION REPORT
Waste Connections LRI-304th St Landfill, Graham, WA

Facility Name: Waste Connections LRI-304th Street Landfill

Date of Inspection: On Site Inspection: May 2, 2022
Virtual Conference: May 4, 2022

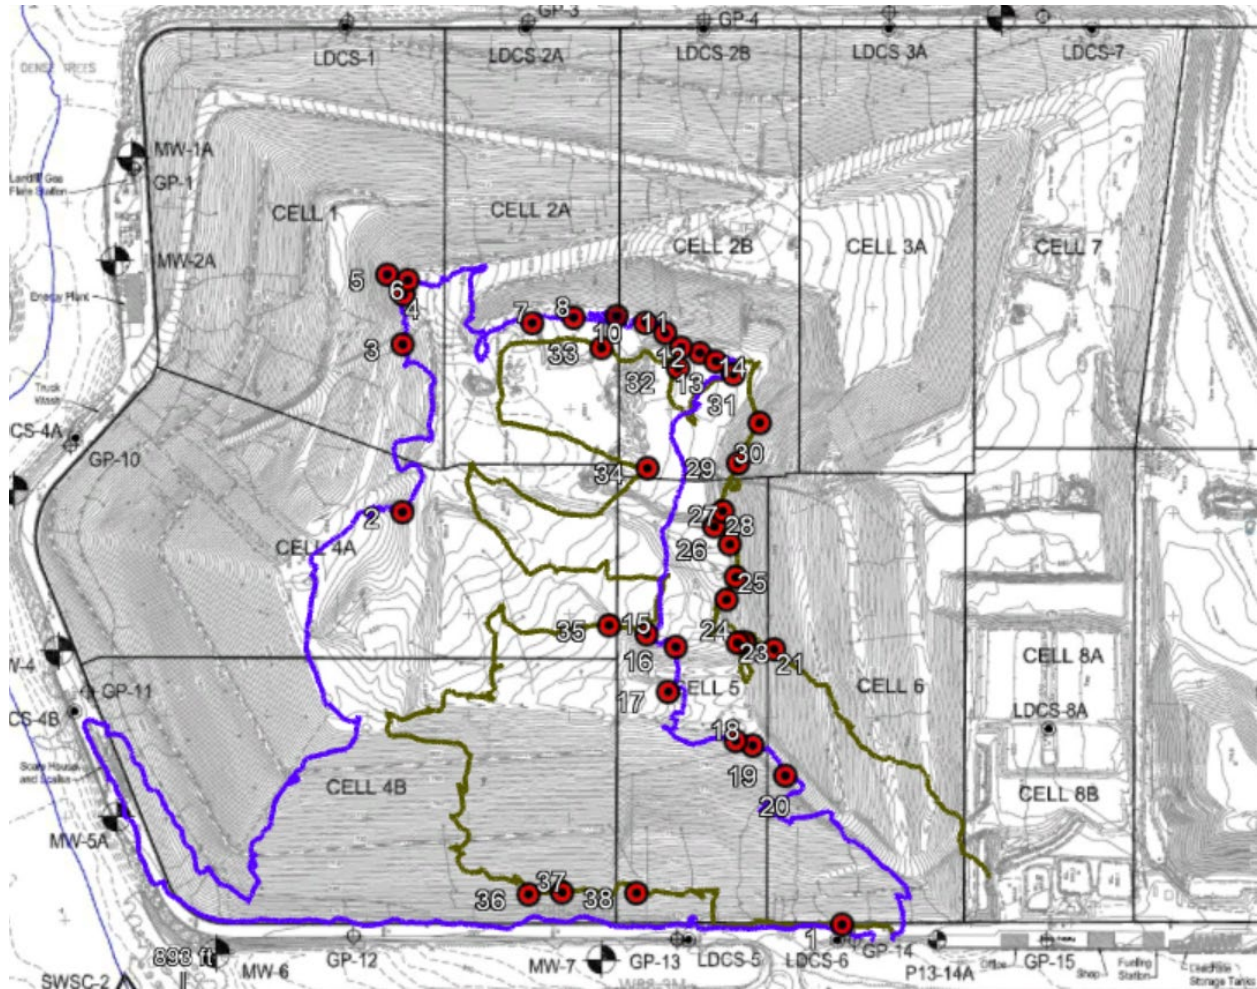
Map of Detected Exceedances

EPA identified and flagged 38 parts of the landfill in exceedance of 500 parts per million (ppm) methane, summarized in Appendix B. Exceedances were identified at penetrations, tarp holes/edges, in ditches, and in exposed waste, among other locations. Multiple flagged exceedances included multiple points of exceedance in the vicinity, and some represented broad areas of exceedance. An area of the northwest corner of the Landfill in Cell 1 was identified as an area of concern, as there appeared to be no gas collection in the area and widespread exceedances. Additionally, the tarped area around the meeting of Cells 2B, 3A, 5, and 6 appeared to be visibly inflated with landfill gas, with the tarp being pushed upward away from the surface and held down in place with sandbags and webbing straps, giving the area a quilted appearance. The edges of this section were buried under gravel, and the inflated appearance was stable and constant, independent of wind. Holes in the tarp had strong odors and resulted in measured exceedances over one foot in the air. The TVA had its reading maxed out, indicating explosive concentrations of methane.

SEM exceedance locations with flag numbers plotted over map of the Landfill dated to March 2021. Base map acquired during September 2021 inspection. Approximate monitoring paths included, derived from GPS data: blue for morning, green for afternoon. North is to the left.
